KENCO ENGINEERING COMPANY

MODEL KDV SERIES "FREEZELESS" DUMP VALVE INSTALLATION AND OPERATING INSTRUCTIONS

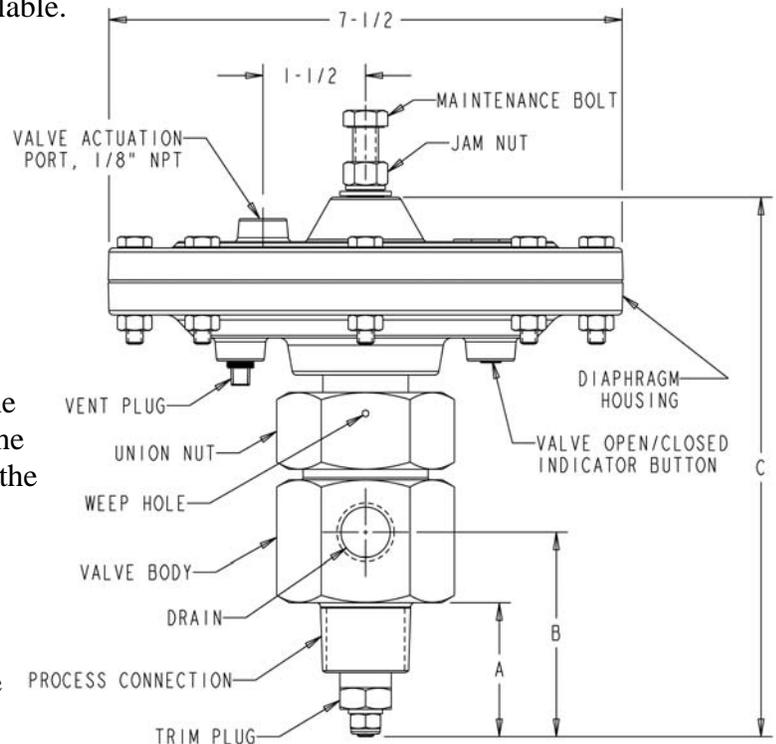
FIGURE 1; DIMENSIONS AND SPECIFICATIONS

VALVE MODEL	PROCESS CONNECTION SIZE	DRAIN SIZE	MAXIMUM PROCESS PRESSURE	TRIM SIZE	DIMENSION "A"	DIMENSION "B"	DIMENSION "C"
KDV-P18-1-05	1-11.5 NPT	1/2-14 NPT	1800 PSI	.461"	1.88"	2.88"	7.69"
KDV-P18-1-075	1-11.5 NPT	3/4-14 NPT	1800 PSI	.461"	1.88"	2.88"	7.69"
KDV-P05-2-1	2-11.5 NPT	1-11.5 NPT	500 PSI	.865"	1.92"	3.54"	8.76"
KDV-P15-2-1	2-11.5 NPT	1-11.5 NPT	1500 PSI	.589"	2.02"	3.64"	8.86"
KDV-P20-2-1	2-11.5 NPT	1-11.5 NPT	2000 PSI	.446"	2.02"	3.64"	8.86"

NOTE: ALL DIMENSIONS ARE IN INCHES.

Operating Process Pressure: Up to 2000 psi, depending on model (See figure 1)

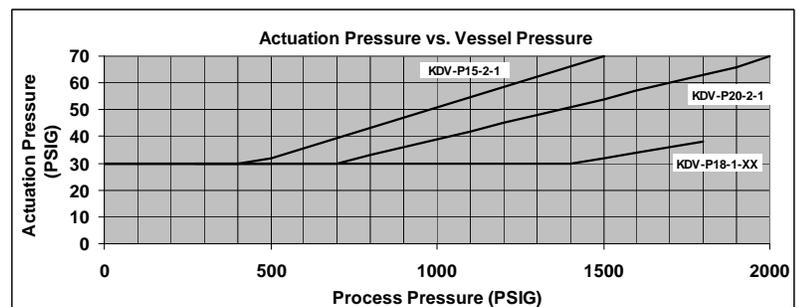
FIGURE 2

(NOTE: KDV-P05-2-1 HAS A CONSTANT ACTUATION PRESSURE OF 30 PSIG)

Valve Actuation Pressure: 30 to 70 psi depending on process pressure (see figure 2)

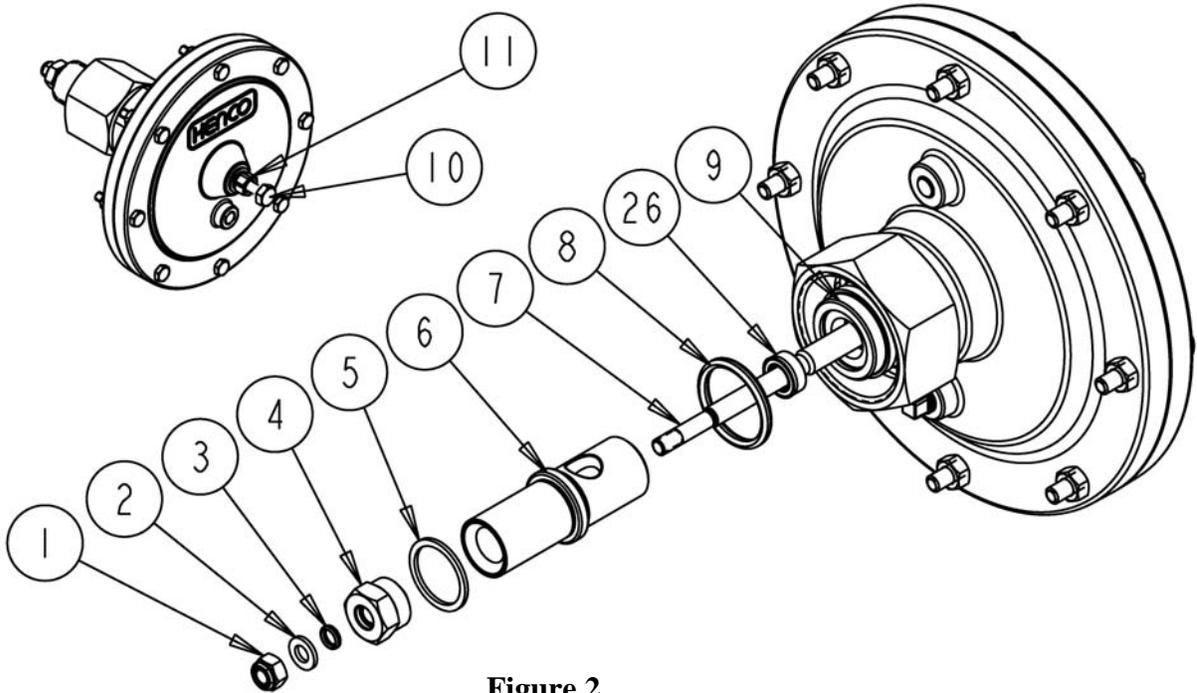
Figure 2

6. Loosen the jam nut (#11) and spin it all the way to the top of the maintenance bolt (#10). (See Figure 2)
7. Screw the maintenance bolt (#10) in until it bottoms and lightly snug. **DO NOT OVER TIGHTEN.** This will take the spring load off of the trim plug, allowing for its removal.

8. With a wrench backing up the trim plug (#4) break the lock nut (#1) loose. Once the lock nut is loose, backing up the trim plug is no longer necessary. The maintenance bolt and diaphragm assembly will provide the resistance needed to remove to locknut.

9. With the locknut removed, remove the washer (#2), o-ring (3), trim plug (#4), crush washer (#5) and trim seat (#6). Also remove the o-ring (#8) from the spud (#9) under the union nut. (Note: if fluid was leaking from weep hole, then replace packing (#26)).

10. Replace all of the parts in the reverse order they were removed. Lubricate the O-rings (and the packing if replaced) with Parker O-ring lubricant or equivalent.

11. When installing the new locknut (#1) on the trim shaft (#7) screw it on until it just contacts the trim plug (#4). Then, using a wrench to back up the trim plug (#4) tighten up the locknut (#1).

12. Loosen the maintenance bolt (#10) until the trim plug (#4) is firmly in contact with the trim seat (#6). Back the maintenance bolt up another couple of turns to make sure it does not come in contact with the trim shaft during normal operation.

13. Spin the jam nut (#11) down against the housing and tighten. The KDV Dump Valve is ready for operation.

8. Remove the o-ring (#25) and insert the new o-ring into the groove in the spud (#9 in figure 2). Use plenty of o-ring lubricant.
9. Smear a thin coat of O-ring lube on the shaft (#24) near the end with the hex. This will help lubricate the o-ring and packing and will improve the life of these seals.

10. Insert the shaft into the spud on the housing (#19). If the valve is a 2” valve, the shaft will have a fairly sharp edge on the shoulder the trim plug (#4 figure 3) bolts up against. Use care when inserting the shaft. The shaft should be gently rotated while applying some pressure to push it past the O-ring (#25). If caution is not used here, the O-ring (#25) and or packing (#26 figure 2) could be damaged.

11. It is easiest to install the packing (#26 figure 2) after the diaphragm assembly is completed. Simply lube the packing thoroughly and work it gently over the trim shaft. Make sure it is oriented properly. The narrow end will sit in the bottom of the groove and the wide end should face the trim plug. **Warning!** If this seal is put in backwards, the valve will leak fluid and/or gas out of the weep hole. Use the trim seat (#6 Figure 2) to fully seat the packing in the groove.

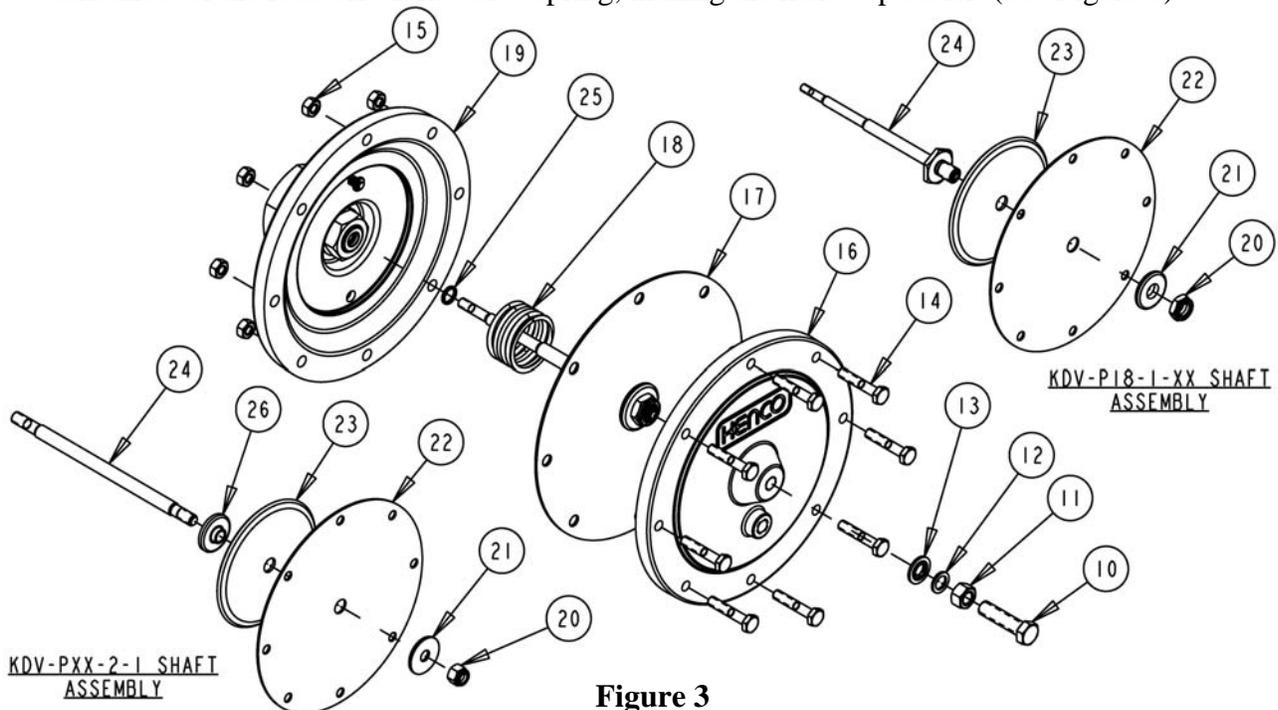
Figure 3

1. Remove the trim plug and seat following steps 1 through 9 under Trim Seal Repair Procedure.
2. Remove the maintenance bolt (#10), nut (#11), flat washer (#12) and seal washer (#13). This will take most of the load off of the valve spring, making the next step easier. (See Figure 3)

3. Make an alignment mark on the housing halves (#16, #19) and remove the eight ¼ “ nuts (#15) and bolts (#14). The valve spring (#18) will probably force the 2 housing halves apart, but if not, gently pry the halves apart with a flat tip screwdriver. Take care not to gouge the sealing surface of the housings.

4. With the two halves apart, remove the old diaphragm assembly (#17).
5. If the valve is a 2” model, slide the washer (#26) on the shaft. Make sure the flat side of the washer sits on the shoulder of the shaft and that the proper end of the shaft is selected.

6. Install the new thrust plate (#23) with the edge of the rolled lip facing the body side of the housing (#19) Use the old assembly for reference if necessary. Also install the diaphragm (#22), washer (#21) and nut (#20). If the valve is a 2” model, the washer (#21) will have a counter bore on one side. This counter bore must face the diaphragm (#22). Failure to orient this washer properly will result in leakage and early valve failure. This only applies to the 2” KDV’s.

7. Use a 1-1/8” wrench to back up the hex end of the trim shaft (#24) and tighten the nut (#20) to 220 in lbs (1”KDV) or 180 in lbs (2” KDV) or until it slightly compresses the surface of the diaphragm (#22).
